LOOSE PARTS WEEKLY DZ1 MEETING

Tuesday, October 1st 2024

SUBARU of INDIANA AUTOMOTIVE, INC.

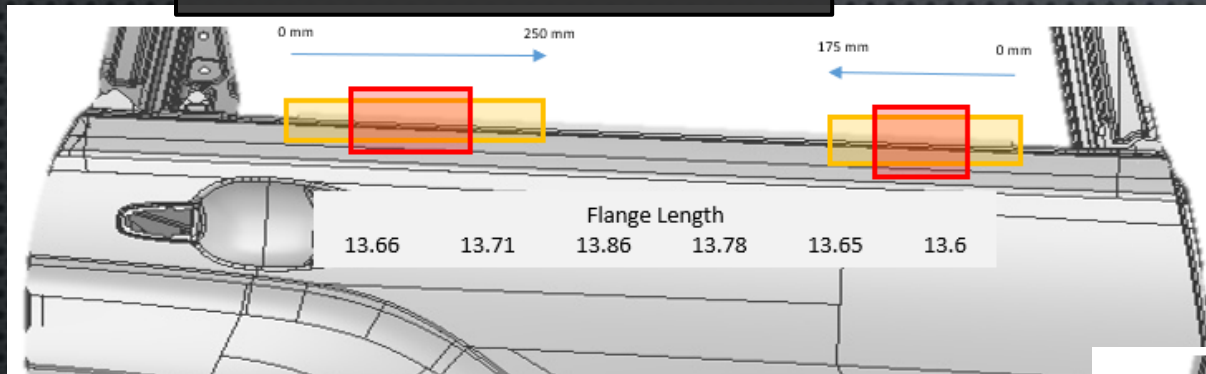
Before this week's adjustments

RRD Roller Hem

Over 2.9 mm thick
Over 2.8 mm thick

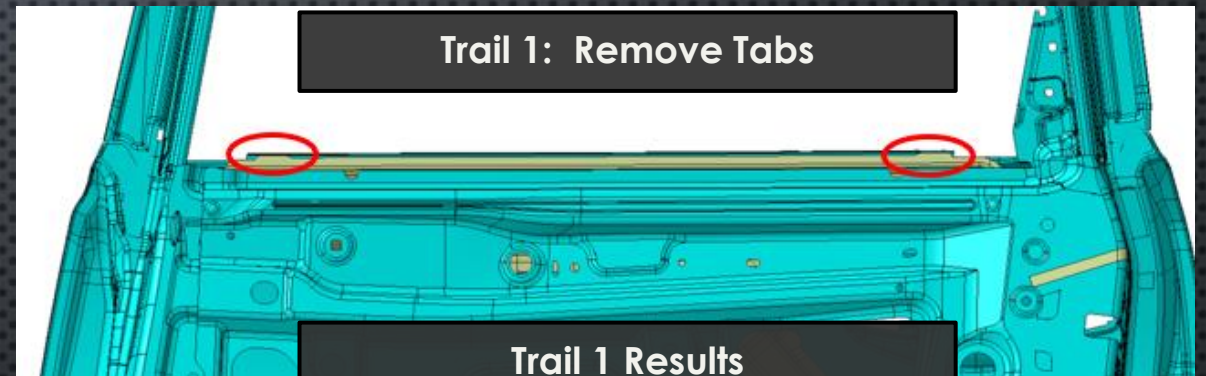
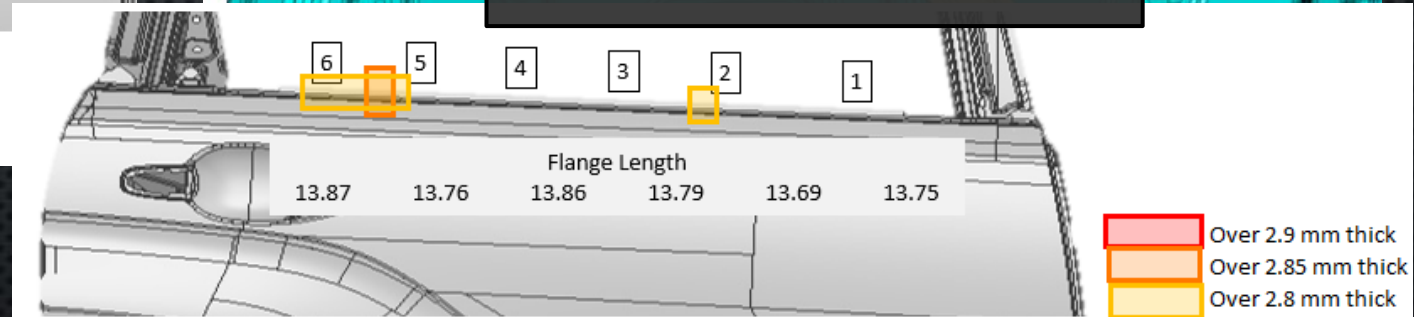
Trail 1: Remove Tabs

Over 2.9 mm thick
Over 2.85 mm thick
Over 2.8 mm thick

Trial 1 saw improvement of flange length near the hand work areas, reduction in hem thickness out of spec

Flange Length Comparison:

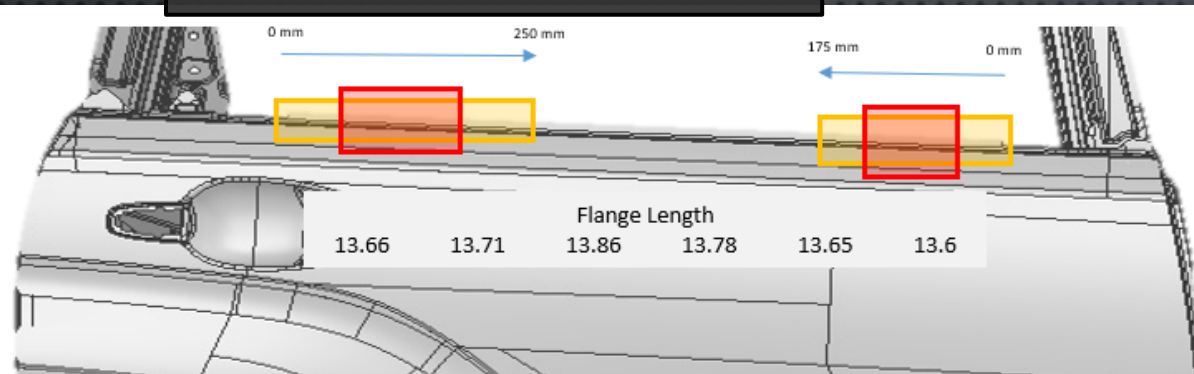
Before this week's adjustments

- Over 2.9 mm thick
- Over 2.8 mm thick

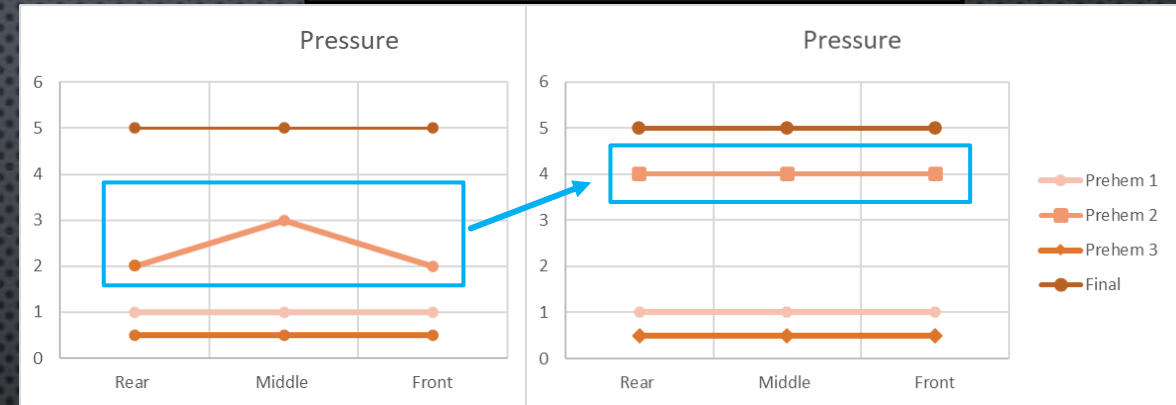
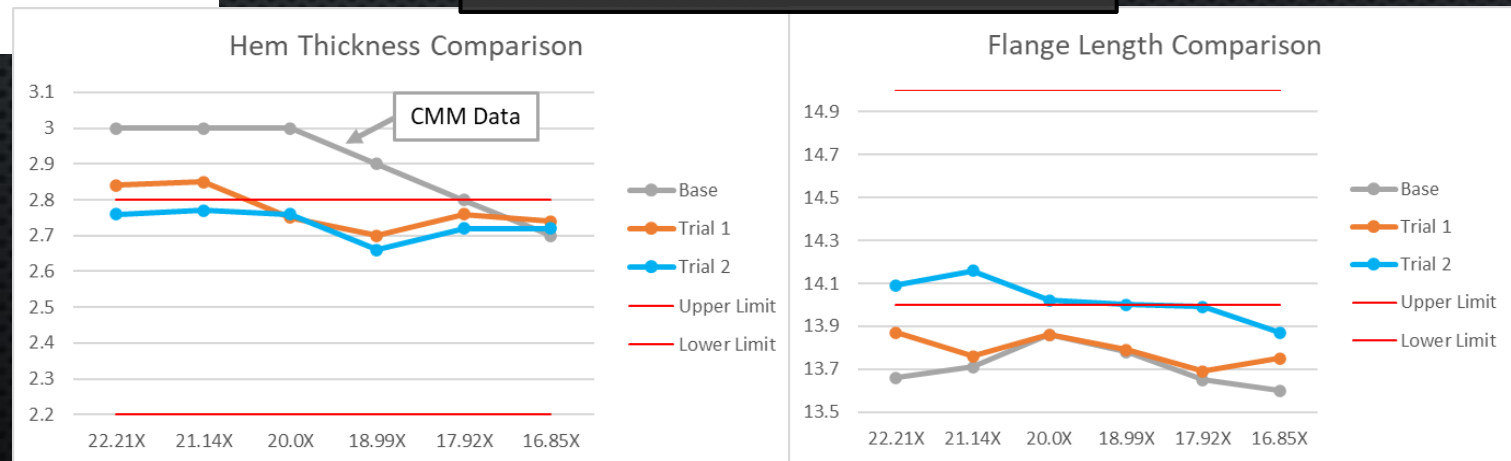
Trail 1 & 2 Results

- Trial 2 has best hem thickness condition
- Trial 2 has best flange length condition

Trail 2: Prehem 2 Press to 4

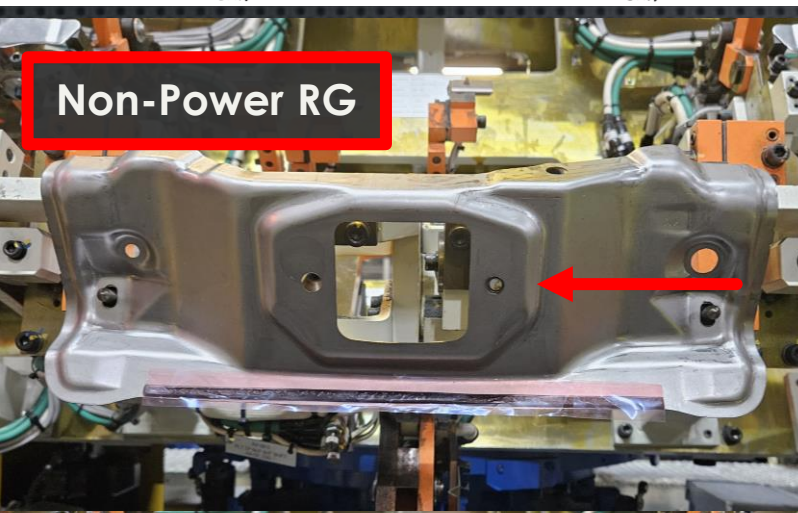
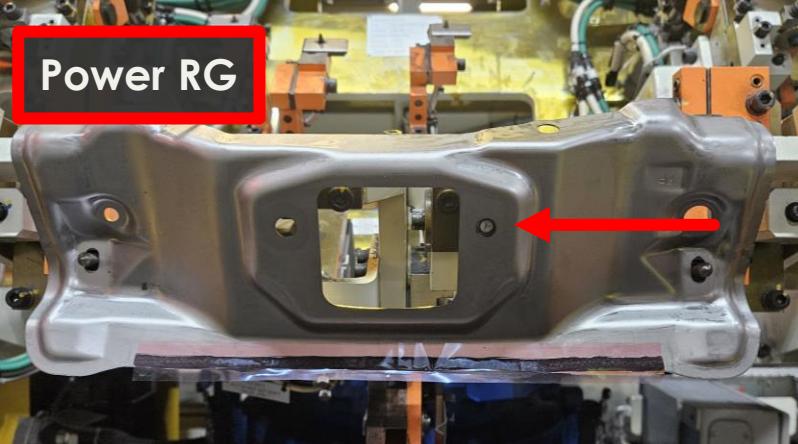
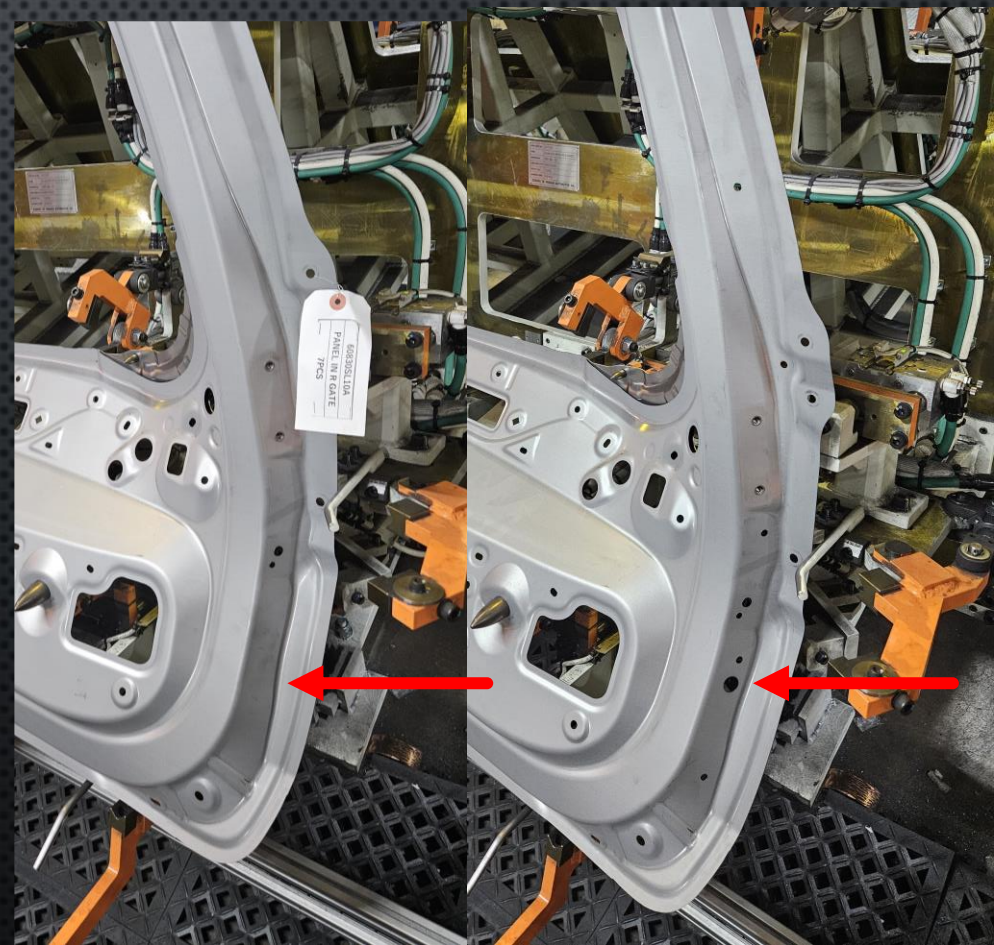
SBR Yokoten - RG built with mismatching power/non-power RG Latch

Problem: 2 prox sensors detect power/non-power RG inner & latch. Sensing distance is limited, so the inner can be set without being detected properly. (After RG is clamped, misset is detected, but sensor is at range limit)

Countermeasure: Additional sensor for RG inner panel detection (right side picture)

Progress: Brackets installed (4), sensors wired (4), PLC ready (4), 3D printed mounts (1 of 4).

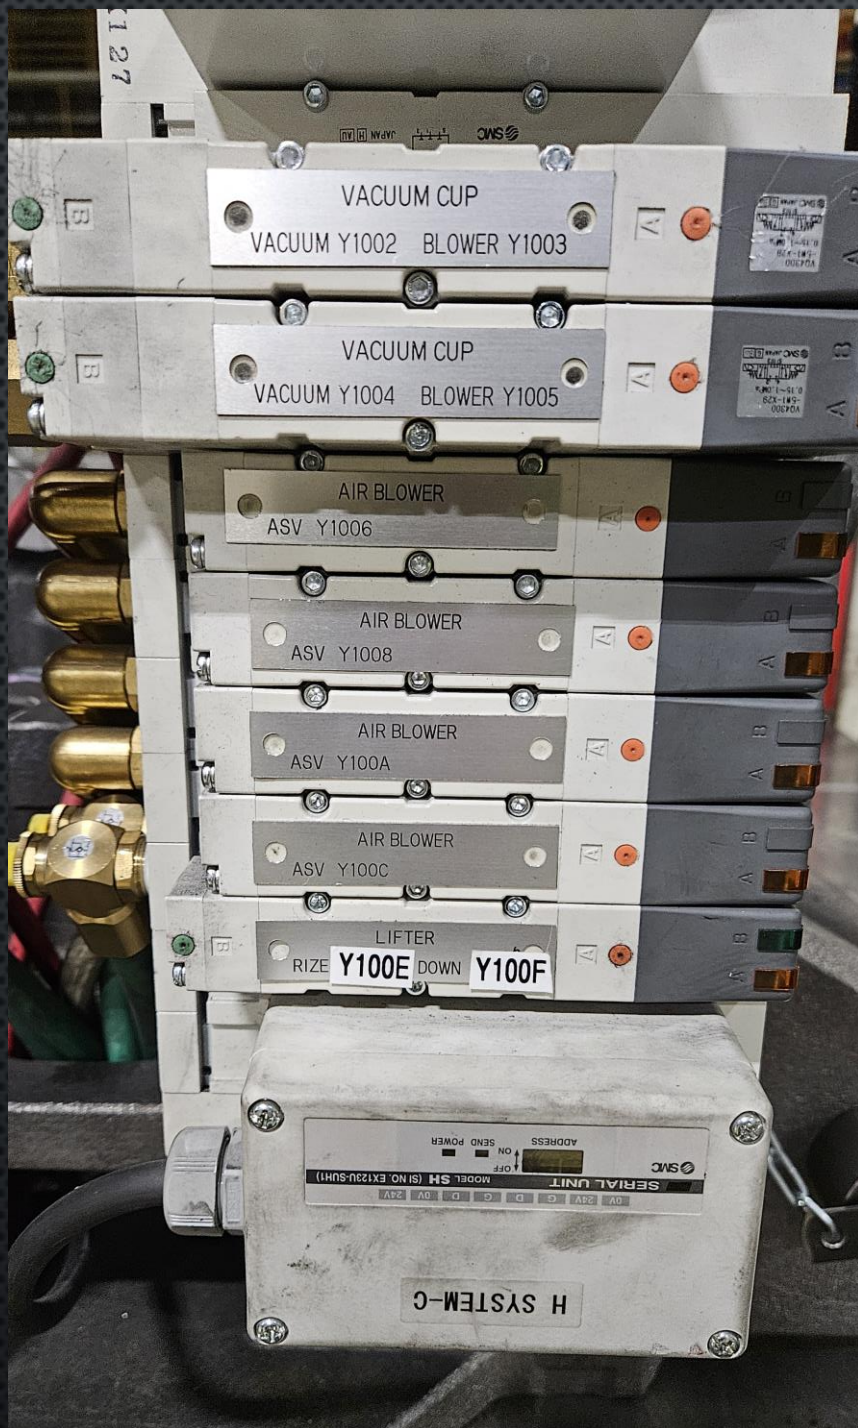
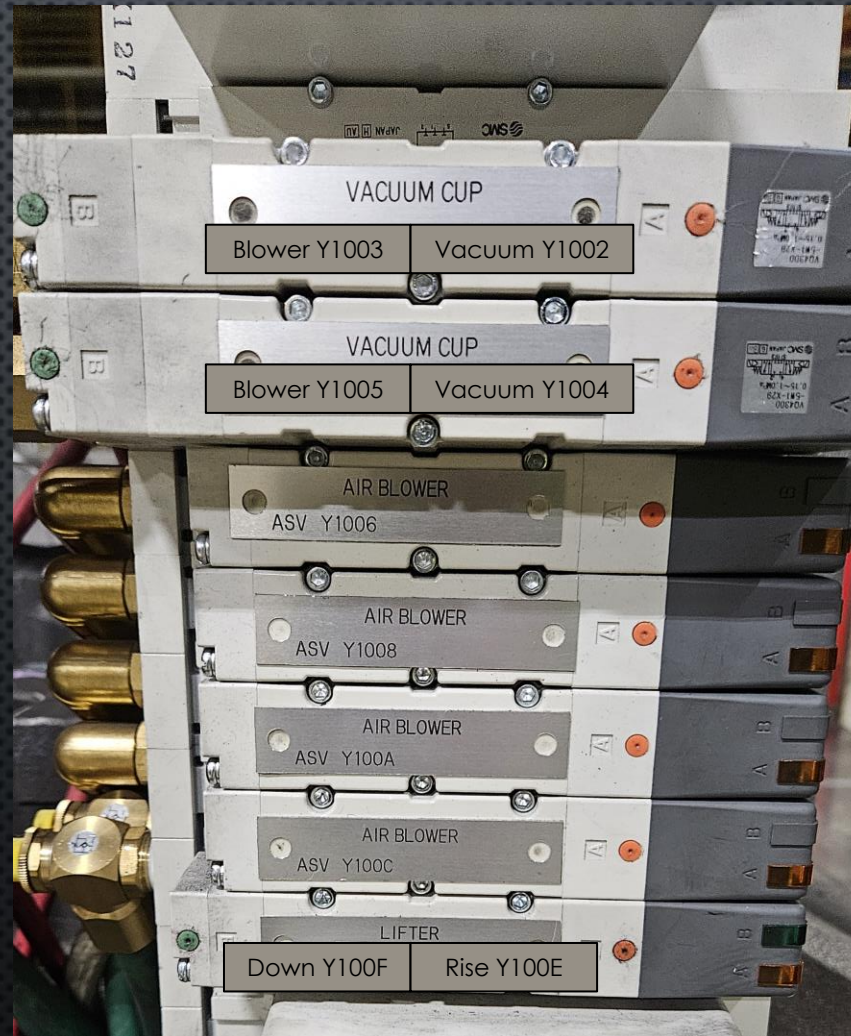
38. Hood Hem Press –
Labeling needs fixed

9/24: A Line Hood Air Pack
shown on left corrected.

Need to check others
